## Analysis of Water Contaminated Engine Oil in Engine Generator Set

*This case study was conducted in a manufacturing company that experienced a breakdown in a power generator set. A standard investigation was carried out by opening the crankcase cover and checking the dipstick. The results of the visual inspection showed that the engine oil was contaminated with water. Therefore, this study was conducted to further analyze the causes of oil contaminated with water in the unit being handled using fault tree analysis (FTA). As a result, cracks were found in the cylinder liner due to pitting on the outer liner with a pitting depth of more than 2 mm. In our analysis, pitting is formed due to the presence of air bubbles in the cooling system. Based on FTA, the formation of air bubbles is caused by the quality of the coolant. We also found that the coolant used was not added with any additives.*

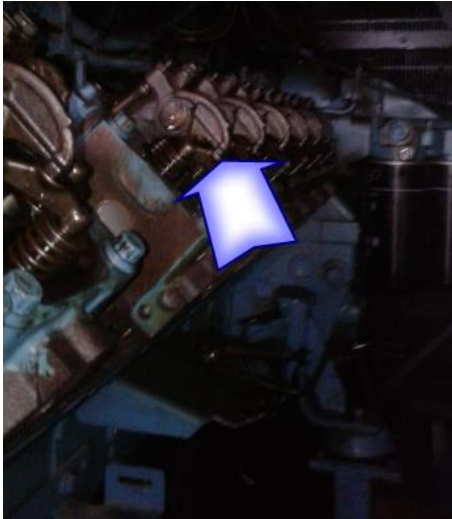
In Figure 3 the rocker arm is rusty caused by condensation when the engine oil is contaminated with water. The steam from inside the crankcase goes to the rocker arm, then the steam flows to the breather. Rust on this engine component if not cleaned immediately, will damage other components.

As described in Figure 3 rust on the surface of the rocker arm intake and exhaust caused by water vapor from the oil pan, this rocker arm as a result, not a cause. It is recommended that if rocker arm rust is found due to moisture, it should be cleaned immediately with clean oil (new oil), so as not to harm other components.

Figure 3. Rocker arm rust

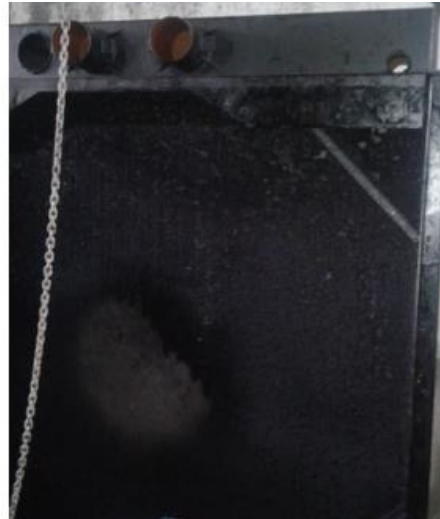
The condition of the radiator on the unit, contaminated with dust, etc., will have an impact on the engine cooling system. This can have an impact on the cooling water circulation system that is not optimal [9], causing the radiator water temperature to increase and can cause overheating [10]. Recommendations for blocked radiator conditions, so that routine maintenance is carried out every 3 months. And when cleaning the radiator, In Figure 4 the condition of the radiator is covered by dust contamination which causes the radiator to be blocked.

Figure 4. Radiator blocked

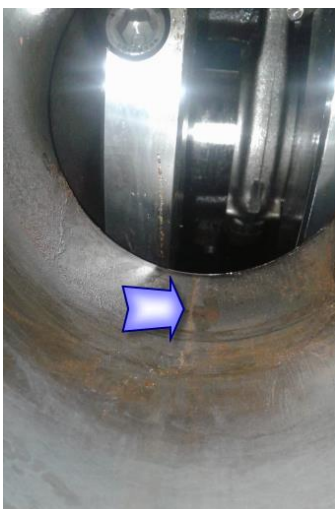
While the surface of the inner liner wall has an indication of rust, which is due to the radiator water being in the combustion chamber, which is described in Figure 5. After identification of the engine oil being contaminated with water, a crack was found in one of the cylinder liner cracks at the bottom of the cylinder liner [11].

Figure 5. Cylinder crack

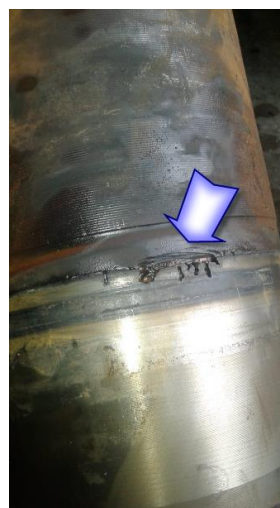
At the time of dismantling the liner, the outer liner wall was found, pitting was found in the bad filler area and the other outer walls, the pitting depth was more than 2 mm (see Figure 6). With the finding of pitting occurring on the outer liner wall [12], the beginning of the cracking of the liner wall. The pitting is formed due to the presence of air bubbles in the cooling system. Air bubbles are formed due to radiator water that does not use additives [13].

Figure 6. Pitting
